CAFO FACILITY INSPECTION REPORT

<p><u>8365786001</u> WDID NUMBER</p> <p><u>CA0108001</u> NPDES NUMBER</p> <p><u>R8-2007-0001</u> RWQCB ORDER NO.</p> <p><u>03/04/2013</u> SCHEDULED INSPECTION DATE</p> <p><u>03/04/2013</u> ACTUAL INSPECTION DATE</p> <p><u>Santa Ana River</u> RECEIVING WATER</p>	<p><u>Augustine Simoes</u> OWNER NAME</p> <p><u>Ontario, CA 91761</u> OWNER CITY AND STATE</p> <p><u>Augustine Simoes</u> OWNER CONTACT</p> <p><u>Ex. 6 Personal Privacy (PP)</u> FACILITY LATITUDE</p>	<p><u>Simoes Dairy -- Riverside</u> FACILITY NAME</p> <p><u>Ontario, CA 91761</u> FACILITY CITY AND STATE</p> <p><u>Al Simoes</u> FACILITY CONTACT</p> <p><u>909-615-9397</u> FACILITY PHONE NO.</p> <p><u>Ex. 6 Personal Privacy (PP)</u> FACILITY LONGITUDE</p>
---	---	---

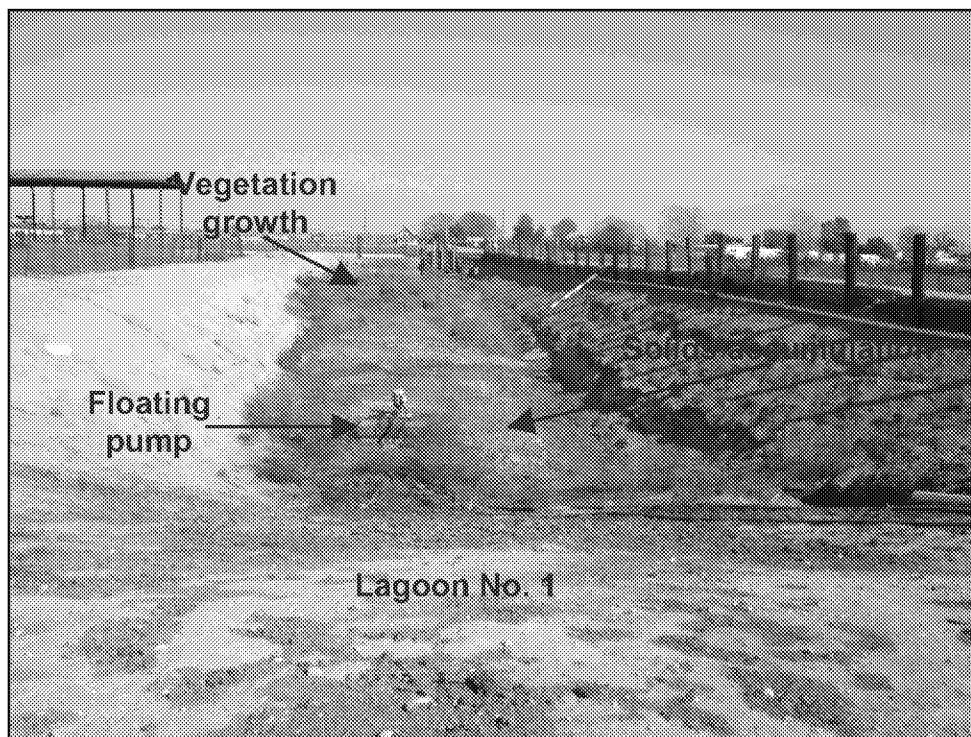
- Depth markers were not installed in lagoon No. 1 or basin Nos. 2-7 (refer to Photos 2, 3, and 4)
- Weekly Storm Water Management Structure visual inspections did not contain the minimum required information, and were not conducted weekly (refer to Exhibit 1)
- Annual Reports for the previous five (5) years were not available for review
- Manure Tracking Manifests are not documented or maintained of all haul events by the Discharger
- The Engineered Waste Management Plan (EWMP) was not retained onsite or available for review at the time of the inspection
- The Site Plan was not reflective of current Facility conditions
- Daily inspections of all ponds, berms, and wastewater distribution and application equipment was not being conducted during the wet season as specified in the approved EWMP
- Facility process wastewater application fields are not disked per the approved EWMP frequency

1. Depth markers were not installed in lagoon No. 1, and basin Nos. 2 through 7 as required by Permit Attachment B - Monitoring and Reporting Program, Section I.B.1 (refer to Photos 2, 3, and 4).

1. The inspectors observed, during the inspection, that depth markers were not installed in lagoon No. 1 or basin Nos. 2 through 7 (refer to Photos 2, 3, and 4) to indicate the minimum capacity necessary to contain the runoff and direct precipitation of the 25-year, 24-hour rainfall event, as required by Permit Attachment B - Monitoring and Reporting Program, Section I.B.1. It should be noted that a depth marker had been installed in basin No. 1.

2. The inspectors observed, during the inspection, that vegetation growth potentially affecting the containment structure capacity was present in lagoon No. 1 (refer to Photos 2 and 5). The EWMP states that weed abatement be performed to ensure adequate capacity is maintained within the containment structures. As a result, the overall capacity of the containment structures at the Facility may be diminished. The Discharger must design and maintain all containment structures per the EWMP as required by Provision VII.C.3.a of the Permit.

3. The inspectors observed, during the inspection, that approximately six to eight inches (6-8") of accumulated manure solids was present in lagoon No. 1 (refer to Photos 2, 6, and 7). It should be noted that lagoon No. 1 did not contain a depth marker; therefore, the inspectors were unable to verify the exact depth of manure solids accumulation in the lagoon. The EWMP states that the frequency of solids removal from the basins should depend on the solids accumulation rates; however, "lagoon solids shall be removed every summer to ensure full capacity in the lagoons before the start of the next winter season." Mr. Simoes stated that the lagoon had not been cleaned within the past three (3) years. As a result, the overall capacity of the containment structures at the Facility may be diminished. The Discharger must design and maintain all containment structures per the EWMP as required by Provision VII.C.3.a of the Permit.

Photograph 2. View facing west of lagoon No. 1. Note the lagoon did not contain a depth marker and was observed containing vegetation growth and accumulated solids.

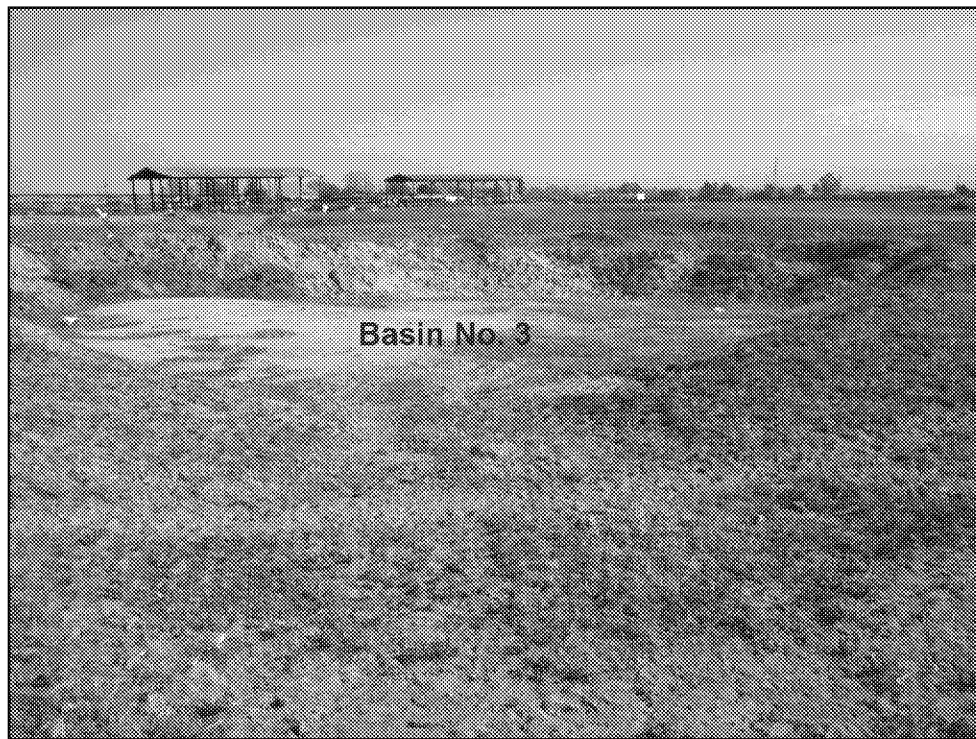
Photograph 3. View facing southeast of basin No. 3. Note the basin did not contain a depth marker.

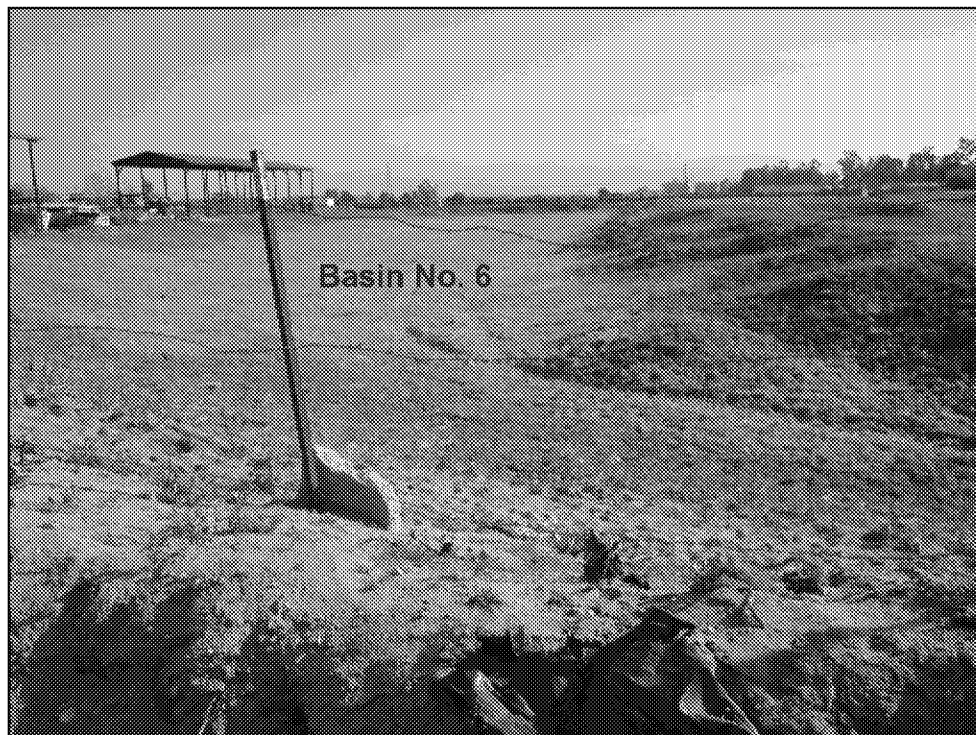
Photograph 4. View facing south of basin No. 6. Note the basin did not contain a depth marker.

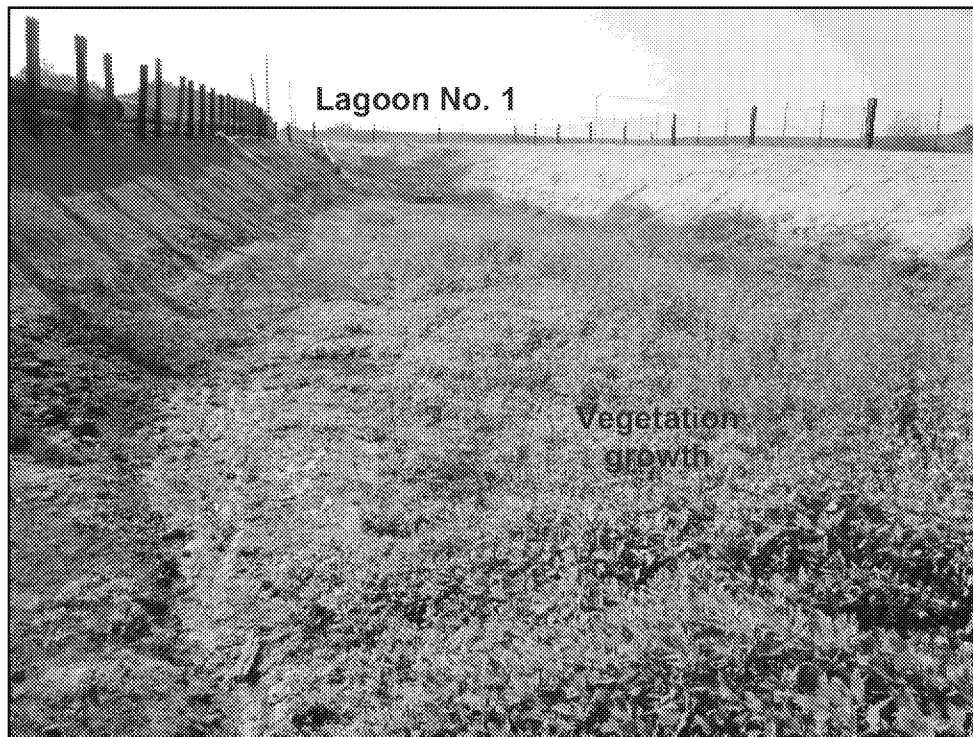
8. Accumulated solids and vegetation growth was observed in lagoon No. 1 (refer to Photos 5, 6, and 7). The Discharger must design and maintain all containment structures per the EWMP as required by Provision VII.C.3.a of the Permit.

Photograph 5. View facing west of vegetative growth inside lagoon No. 1, also shown in Photograph 2.

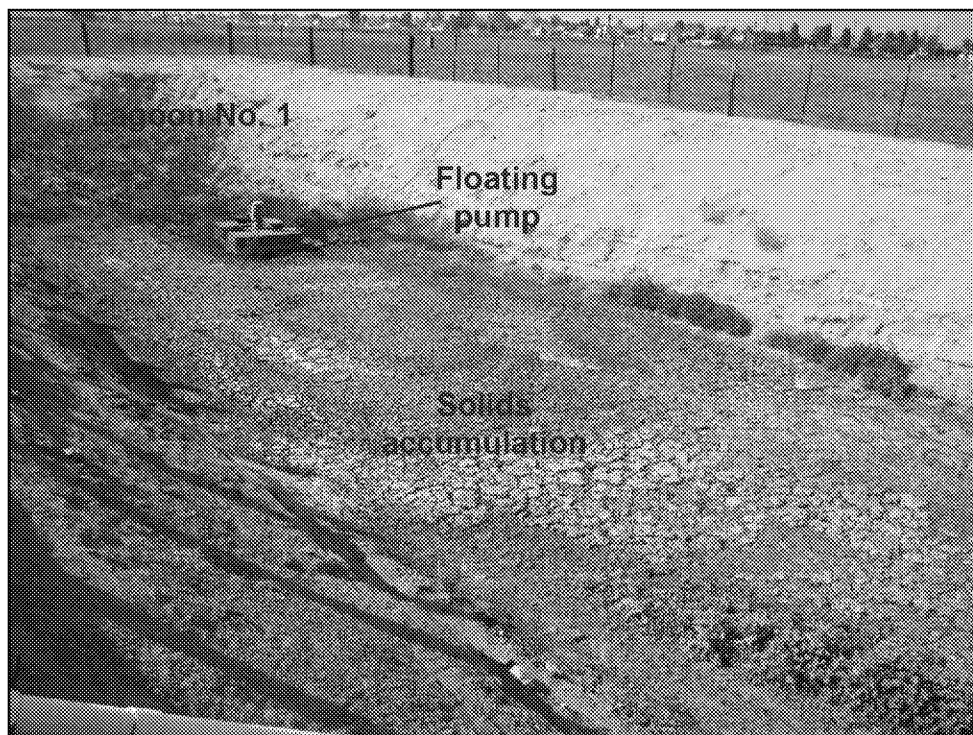
Photograph 6. View facing northwest into lagoon No. 1. Note the accumulated solids, also shown in Photograph 2.

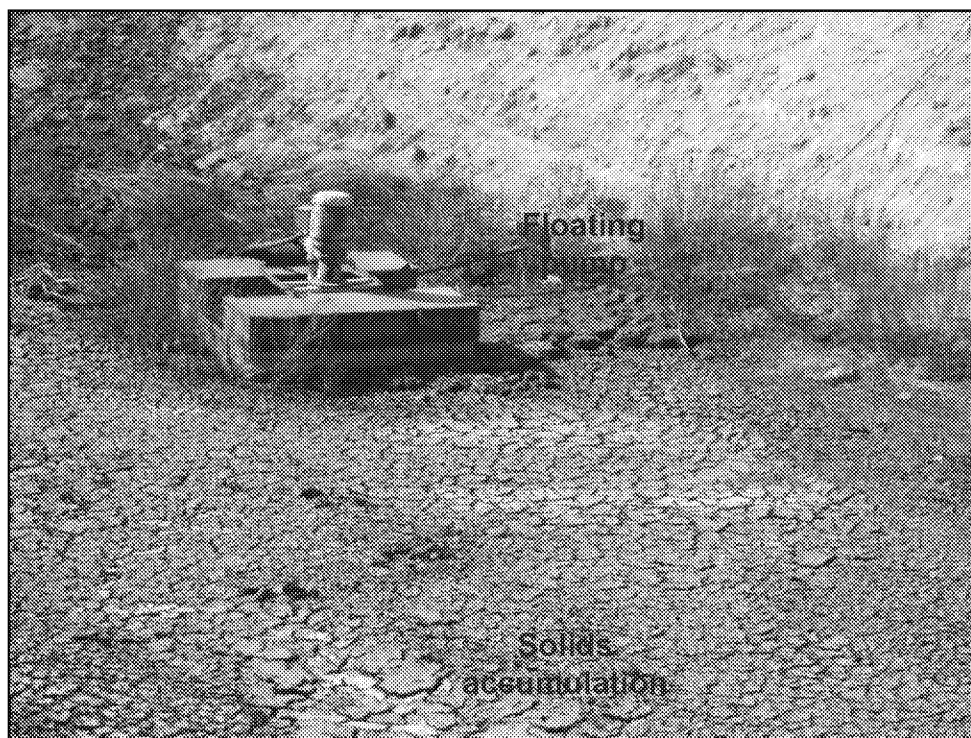
Photograph 7. Close-up view of accumulated solids and the floating pump in lagoon No. 1, shown in Photographs 2 and 6.

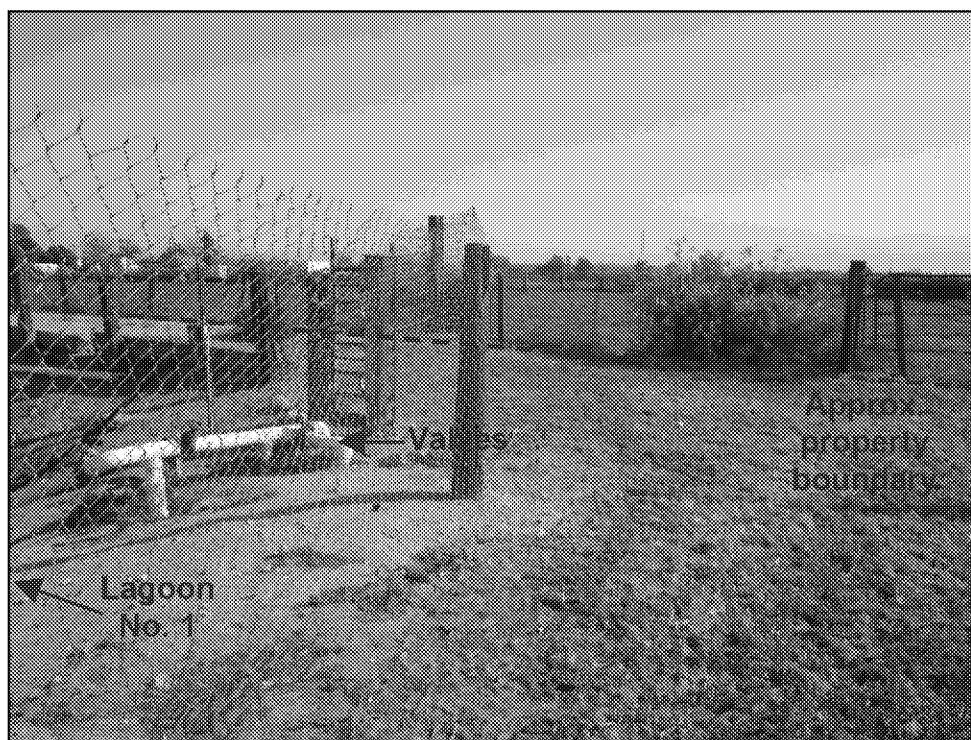
9. Process wastewater and surface runoff that accumulates in lagoon No. 1 is currently applied on pasturelands at an adjacent property immediately south of the Facility, which is not owned or operated by the Discharger (refer to Photos 8 and 9). Discharge of process wastewater and/or storm water runoff from manured areas to property not owned or controlled by the Discharger is prohibited as stated in Discharge Prohibitions IV.A of the Permit.

4. The inspectors identified an illegal process wastewater discharge practice during the inspection. The inspectors observed, during the inspection, a process wastewater line equipped with two valves in the southwest corner of lagoon No. 1 (refer to Photos 8 and 9). Mr. Simoes stated that the valves are used to send lagoon wastewater to two neighboring properties to the south of the Facility for land application. Mr. Simoes stated the last time

wastewater from the lagoon was applied at the neighboring properties was in Decemeber 2012. According to Mr. Simoes, the neighbors use the wastewater to irrigate pastures for livestock grazing. Discharge of process wastewater and/or storm water runoff from manured areas to property not owned or controlled by the Discharger is prohibited as stated in Discharge Prohibition IV.A of the Permit.

Photograph 8. View facing south of valves located in the southwest corner of lagoon No. 1. Note the valves are used to transfer process wastewater and storm water runoff from lagoon No. 1 to two neighboring properties south of the Facility.

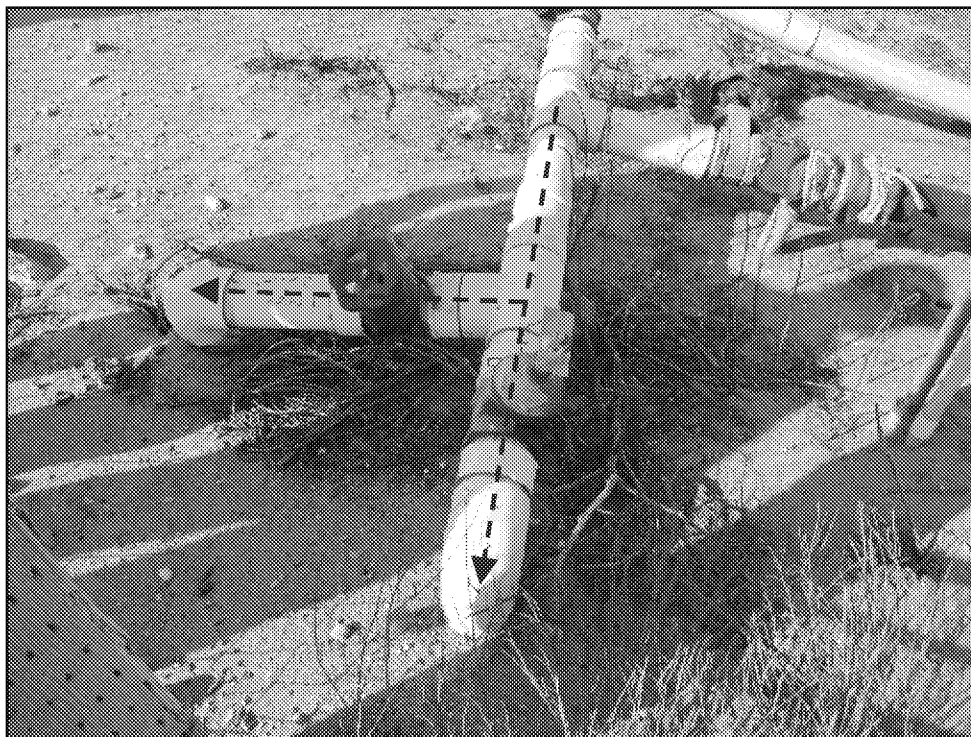
Photograph 9. Close up view of the valves shown in Photograph 8. Both valves used to convey process wastewater and storm water runoff to offsite properties for irrigation purposes were closed at the time of the inspection.

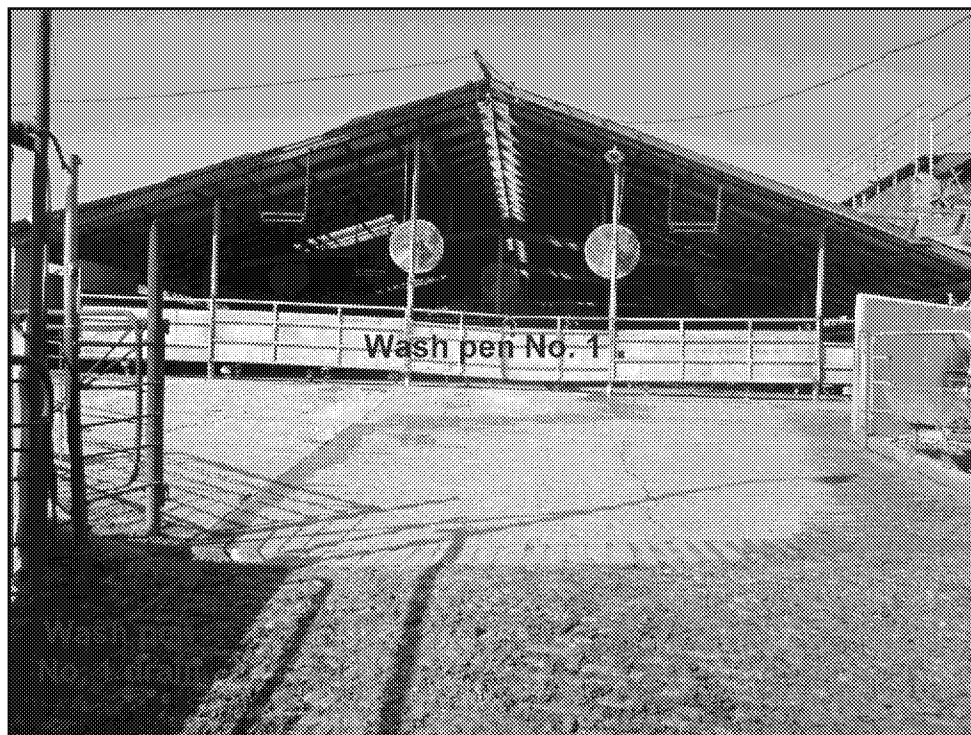
Photograph 10. View facing north of wash pen No. 1 located on the south side of the milking barn. Note all wash water (i.e., process wastewater) from the Facility flows south down the concrete into a drain connected to the milking barn sump pump.

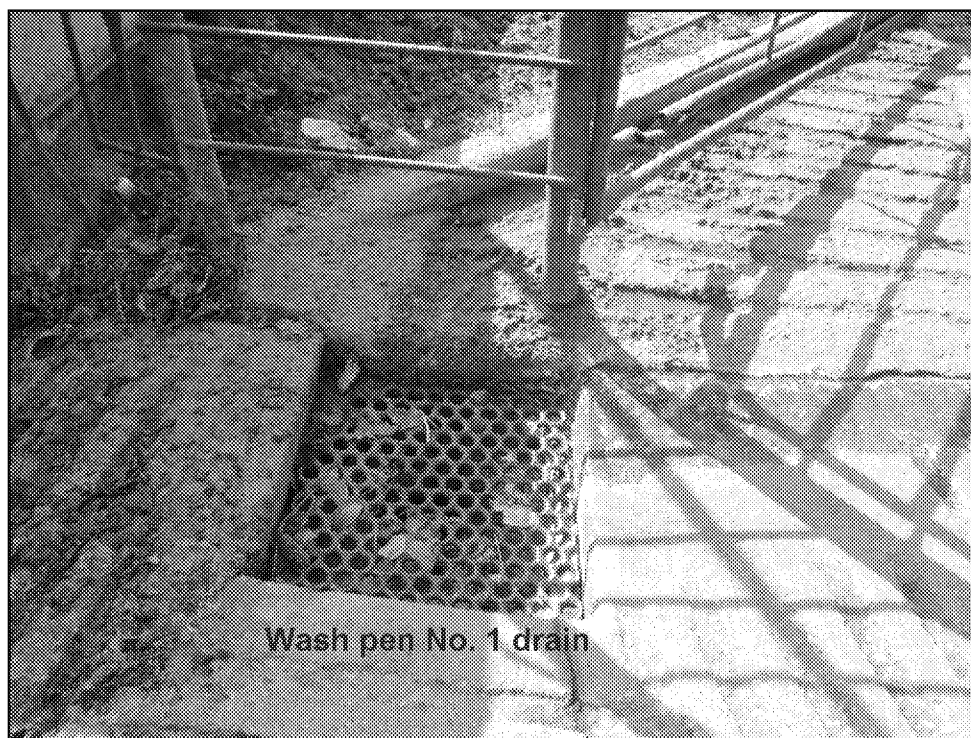
Photograph 11. Close-up view of the wash pen No. 1 drain, south of the milking barn. Note all wash water is captured in this drain, and is piped either to pasture No. 1 for land application or to lagoon No. 1 for storage and evaporation, via the process wastewater sump pump shown in Photograph 12.

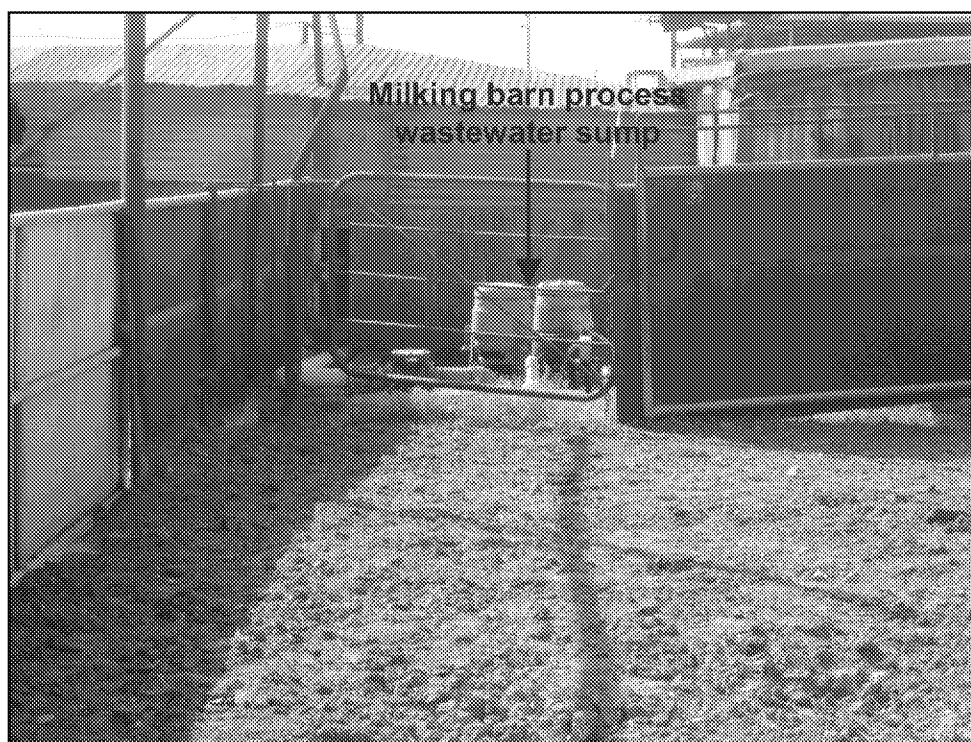
Photograph 12. View facing west of the process wastewater sump pump located southwest of the milking barn.

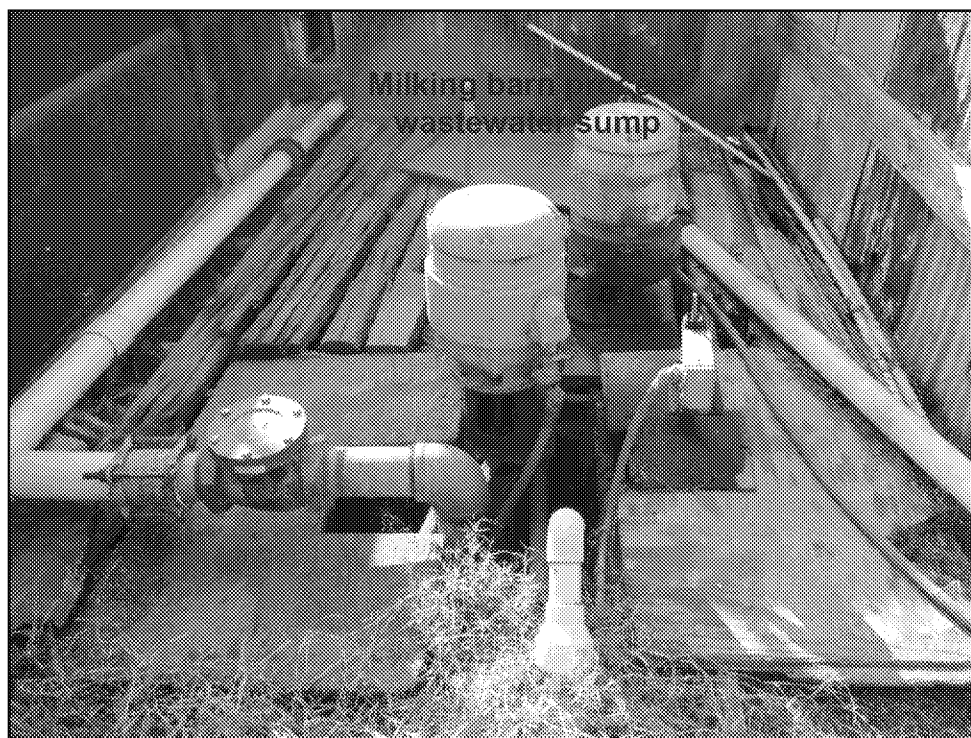
Photograph 13. Close-up view of the process wastewater sump pump located southwest of the milking barn.

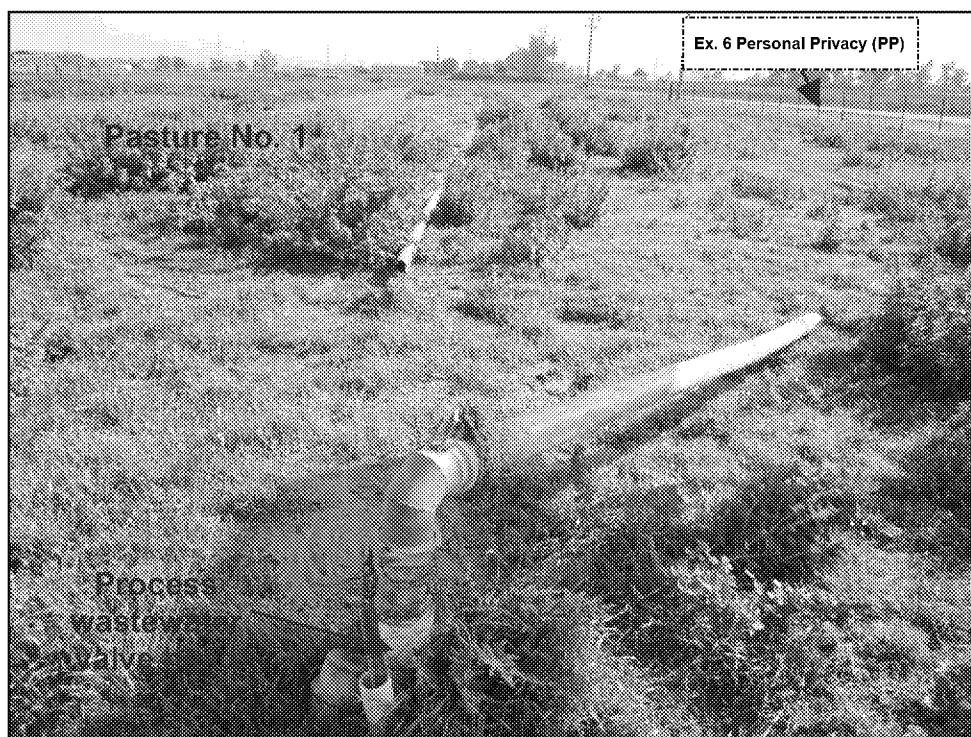
Photograph 14. View facing south of pasture No. 1. Note the valve head and piping used for onsite land application of process wastewater and storm water. Also note four (4) valve heads were observed on the north side of pasture No. 1. The EWMP only identified one (1) valve head.

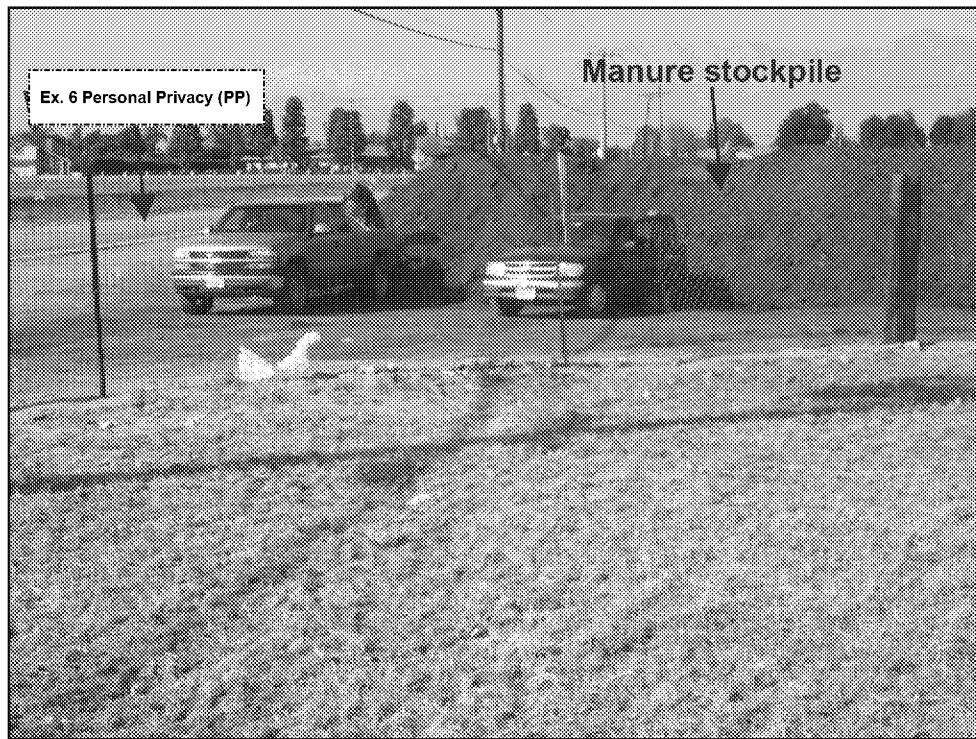
Mr. Simoes stated that the corrals are cleaned/scraped constantly and manure is stockpiled in the central-west portion of the Facility for public use (refer to Photo 15). Manure tracking manifests are not documented or maintained since the public removes manure from the stockpile 24-hours per day. Mortalities are removed from the Facility on an as-needed basis by Stiles Animal Removal, Inc.

3. Manure Tracking Manifests were not documented or maintained of all manure haul events that occur at the Facility as required by the Permit. Specifically, the Facility has a manure stockpile for public pick-up located in the central-east portion of the Facility, adjacent to Walker Avenue (refer to Photo 15). Mr. Simoes stated that maintaining Manure Tracking Manifests is impossible due to the fact that manure is constantly being removed

from the stockpile by public users. Provision VII.C.5.e of the Permit states "a manifest of the manure hauled away shall be prepared and submitted with an annual report in accordance with Monitoring and Reporting Program (Attachment B)." The Discharger must document and maintain Manure Tracking Manifests for all manure that is hauled from the Facility, as required by Provisions VII.C.5.e of the Permit.

Photograph 15. View facing northwest of the manure stockpile located on the central-west perimeter of the Facility. Note the stockpile was available free for public use. Manure tracking manifests are not documented by the Discharger.

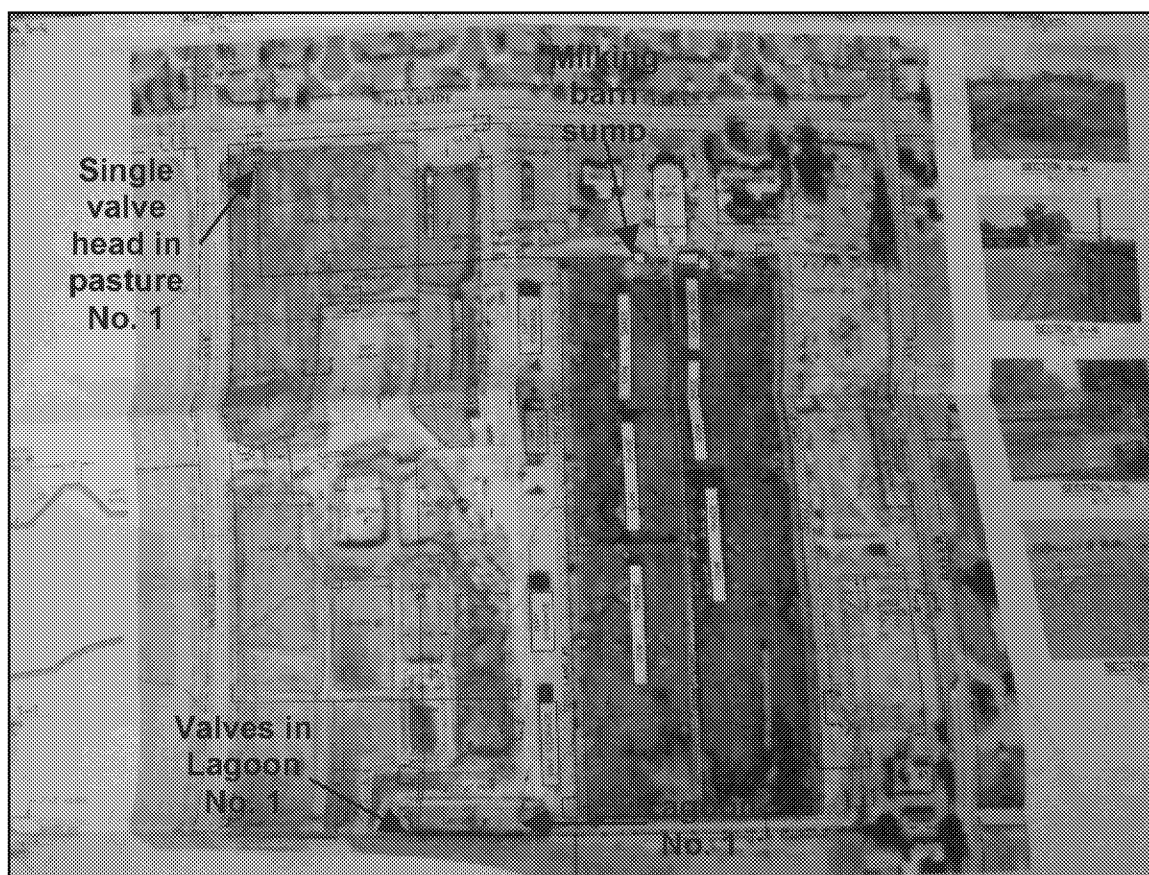
2. The EWMP Site Plan was not representative of current Facility conditions at the time of the inspection as required by Provision VII.C.3.b of the Permit. Specifically, the EWMP Site Plan identifies that process wastewater from the milking barn is pumped from the milking barn sump to the western perimeter of the Facility, then north to a single valve head located in pasture No. 1 in the northwest corner of the Facility (refer to Exhibit 2). As explained by Mr. Simoes, process wastewater from the milking barn sump (refer to Photos 12 and 13) is piped to a corner valve system (where process wastewater can be diverted to lagoon No. 1 or to pasture No. 1 for disposal) located immediately southwest of corral No. 2, then is piped north along the western boundary of corral No. 2, and then west along the northern perimeter of the Facility to four (4) valves heads on the north side of pasture No. 1 adjacent to Riverside Avenue (refer to Photo 14). In addition, a proposed berm around basin No. 1 had not been constructed as outlined in the approved EWMP.

Exhibit 2. Simoes Dairy – Riverside Site Plan. Note the EWMP Site Plan was not reflective of current Facility conditions. The inspectors, observed during the inspection, that process wastewater and storm water disposed of onto pasture No. 1 is applied via four (4) valve heads. The Site Plan only identified one (1) valve head in Pasture No. 1.
